Subject: 12th Street Landfill – Emergency Action
Status Update Report

This letter presents activities performed as part of the 12th Street Landfill emergency action in Plainwell, Michigan, between October 1 and October 15, 2007. Construction at the landfill were limited due to wet weather conditions. Activities completed consisted of the following:

Photographic Log

Client Name:		Site Location:	Project No.:
Weyerhaeuser		12 th Street Landfill Plainwell Michigan	5131.04
Photo No.	Date

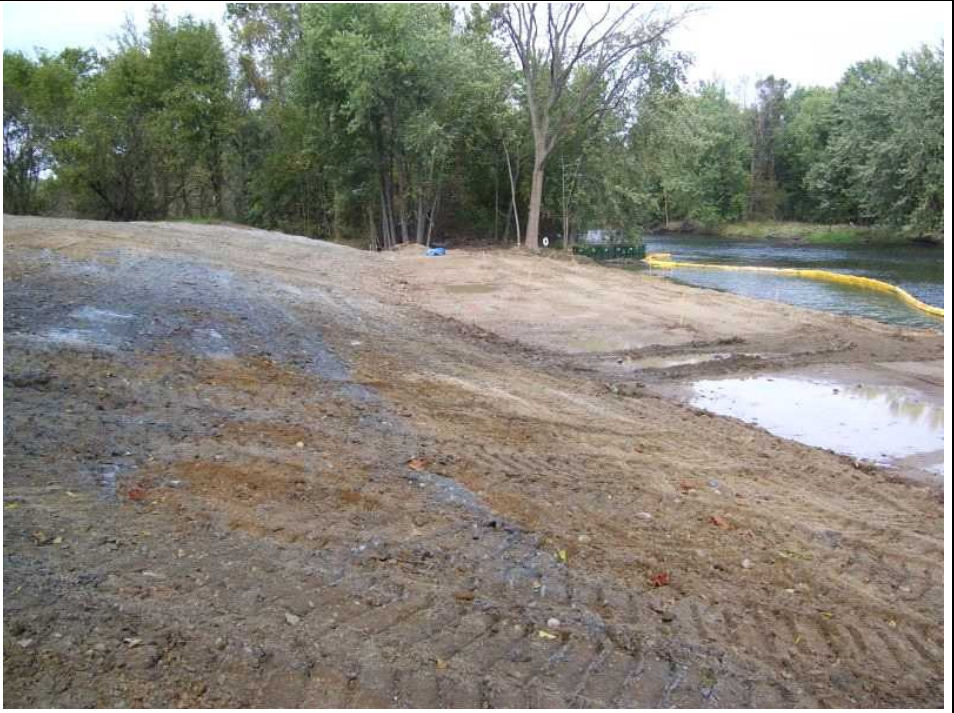
1	10/5/07		
Description			
East face of landfill slope looking north.

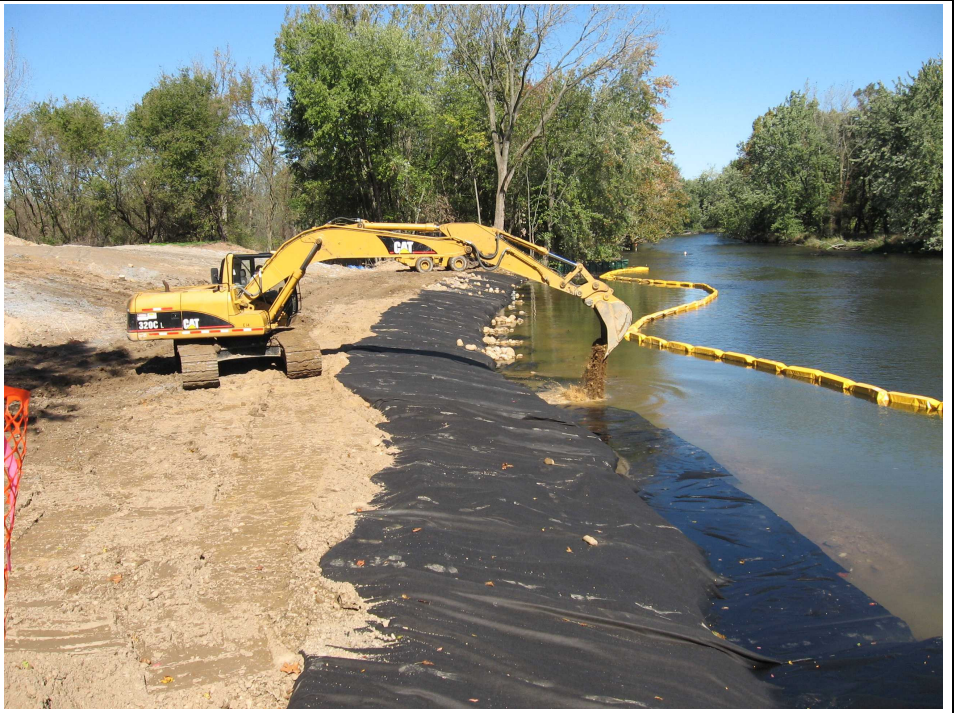
2	10/10/07		
Description			
Placing stone within keyed area at base of slope.

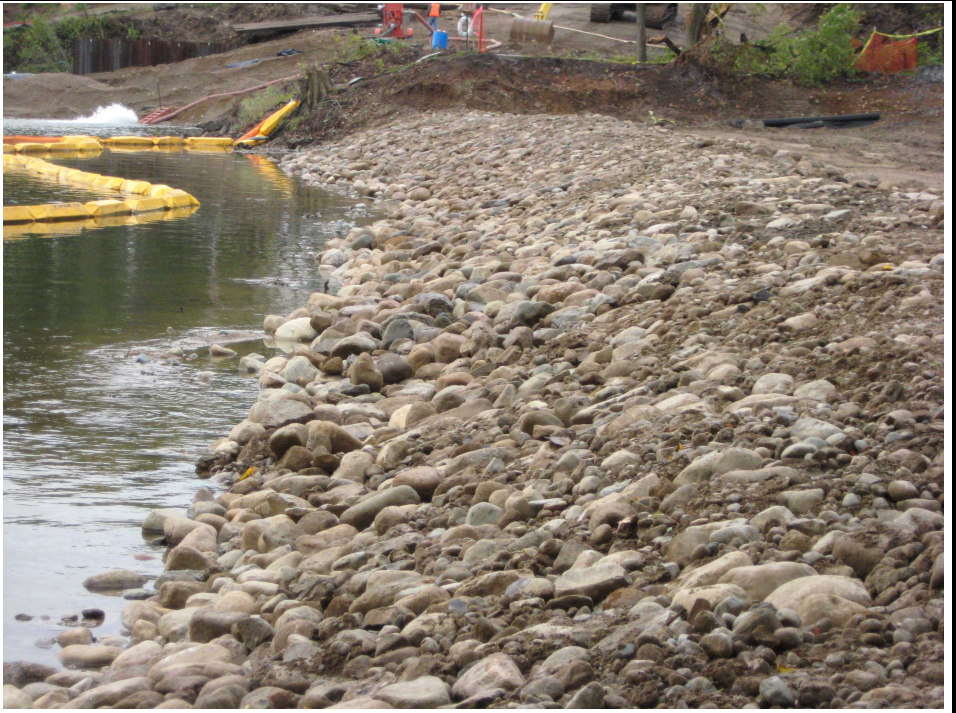
Client Name: Weyerhaeuser		Site Location: 12 th Street Landfill Plainwell Michigan	Project No.: 5131.04
Photo No. 3	Date 10/11/07

Description Riprap placed along shoreline looking south.			
Photo No. 4	Date 10/11/07

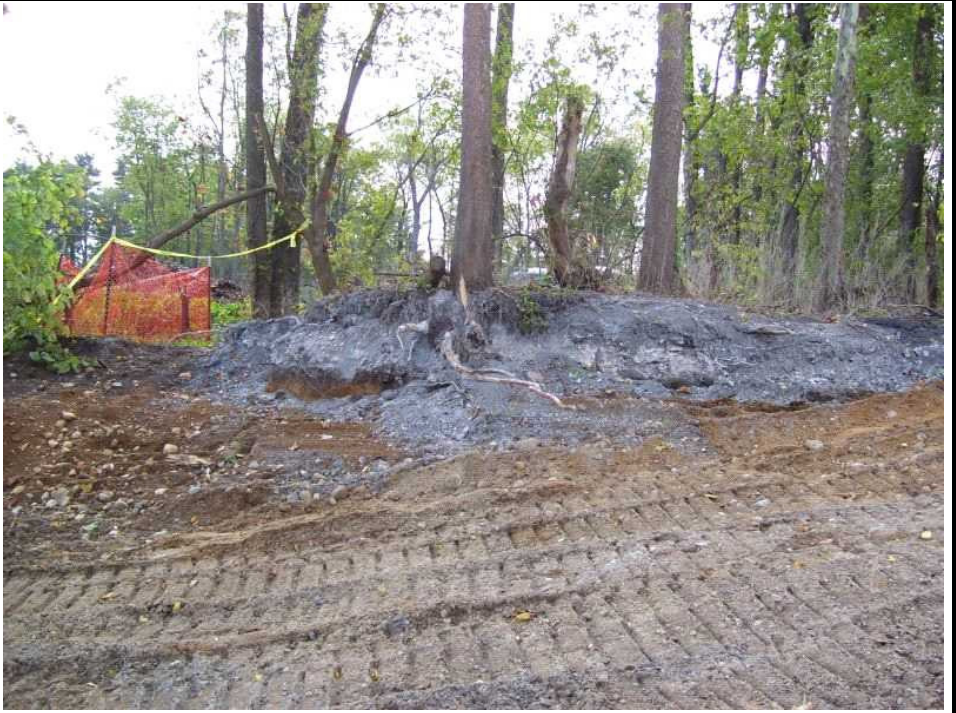
Description Grey residual material within tree roots to be removed and placed within containment pad.

- Remove trees on north and south end of landfill which have visual residuals within root system.
- Place topsoil along access road and east face of landfill.
- Place turf reinforcement mat along access road and face of landfill.
- Cover sediment containment pad with general fill.
- Hydroseed access road, face and top of landfill.
